Manhole Inspection Summary

Manhole # S23K__003MH

Location Address: **347 Ramsey St**

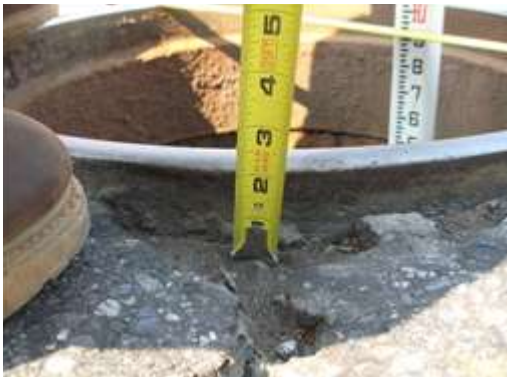
a/b grade

2.25

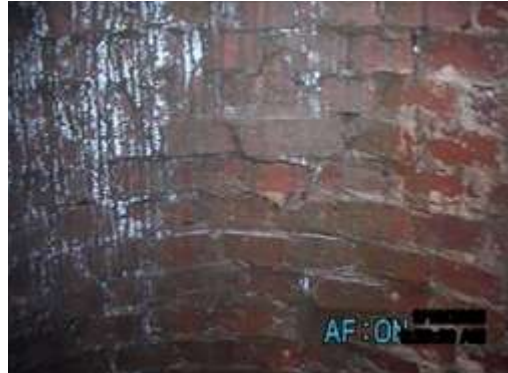
Defect 2

missing rungs

deteriated bricks missing mortar barrel
corbel connect, evidence of infiltration

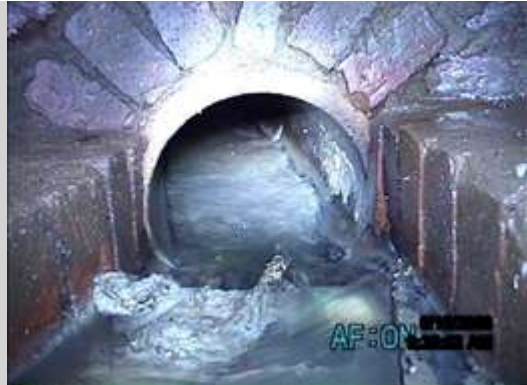
12 O'Clock Outflow

8 in. Circular Gravity Sewer
Pipe Out @ 12 O'Clock

Pipe Height: **8.4** (in.) Rod and Bar (Angled)
Pipe Material: **Clay** ☐ Pipe Lined
Invert Depth: **10.96** (ft.) Flow Characteristics: **Fast**
Deposits: ☒ None ☐ Mud ☐ Sludge ☐ Debris ☐ Grease
Silt Depth: **0** (in.) Deposits Extent:
Infiltration: **Evidence** Pipe Seal Cond: **Unknown**

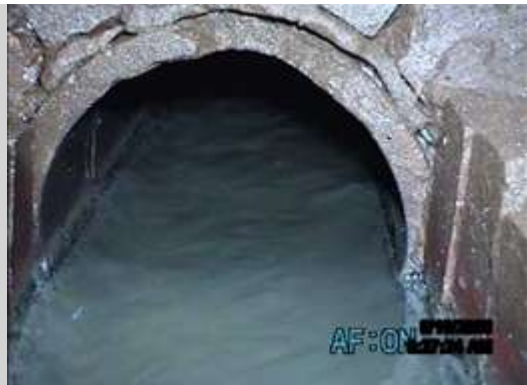
8 O'Clock Inflow

8 in. Circular Gravity Sewer
Pipe In @ 8 O'Clock

Pipe Height: **8.4** (in.) Rod and Bar (Angled)
Pipe Material: **Clay** ☐ Pipe Lined
Invert Depth: **10.91** (ft.) Flow Characteristics: **Slow**
Deposits: ☒ None ☐ Mud ☐ Sludge ☐ Debris ☐ Grease
Silt Depth: **0** (in.) Deposits Extent:
Infiltration: **Evidence** Pipe Seal Cond: **Broken**
